## CASE STUDY

# TUTUKAKA - IPLEX POLYFLOW™ SPOUTING

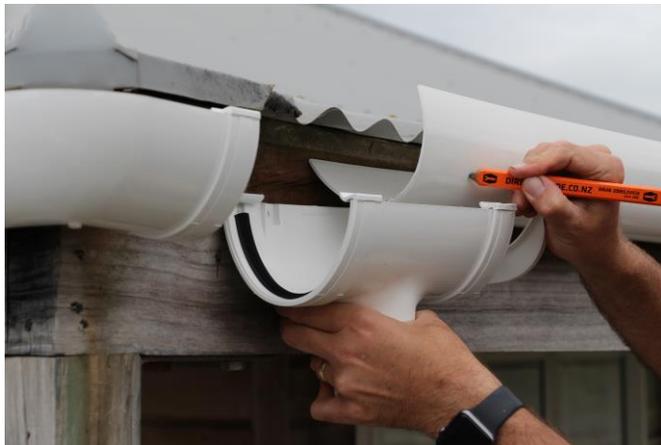
The main buildings have now seen 20 years of service in the coastal (salty air) marine environment. This can take its toll especially on many metallic surfaces that are not easily washed by water or exposed to natural rainfall. In this situation it was the steel fascia brackets that had rusted beyond their practical use.

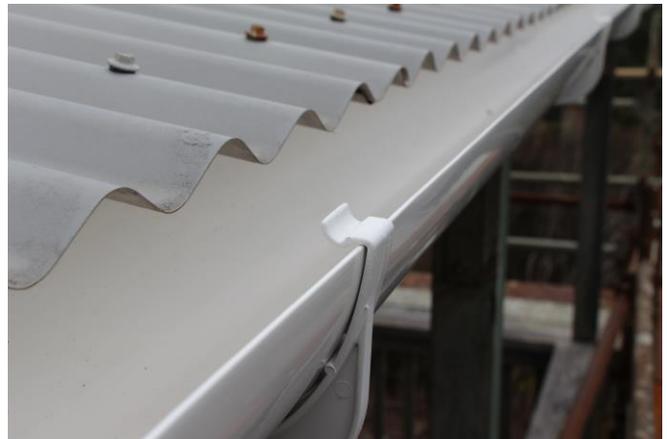
The owners chose the new Iplex Rainwater System made from corrosion resistant PVC-U for their replacement spouting. The Iplex Polyflow™ deep round profile gives extra volume while providing a simple soft shape and colour that compliments the architecture of this building.

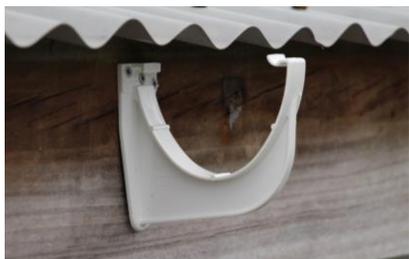
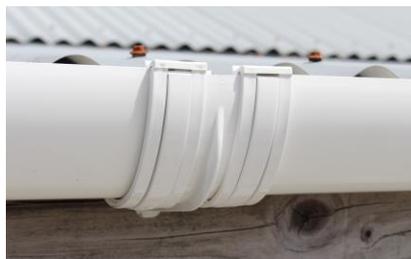
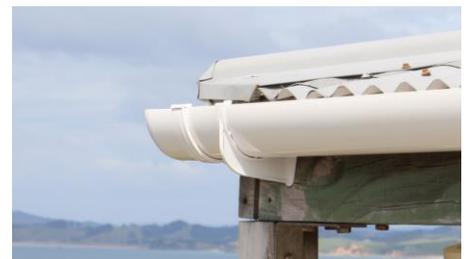
The owners decided to undertake the replacement themselves and quickly found the rubber ring joint and fascia brackets spaced at 1.0m centres made this an easy method of installation. Additional benefits are that the external brackets provide an obstruction free easy cleaning for any leaf build-up that may occur. And of course if any section gets damaged, it is an easy process to simply pop it out and install a new piece.
